TRANSPORTATION RESEARCH CENTER

ON-SITE AIR BAG INVESTIGATION

CASE NO. - 95-06

This report concerns a motor vehicle crash involving an air bag equipped 1990 Lincoln Continental, 4-door sedan and a 1993 Chevrolet, G-20 (3/4 ton), 4x2, conversion van occurring on [REDACTED], [REDACTED] 1995 at 5:25 p.m., in [REDACTED], Indiana on a [REDACTED]. This crash is of special interest because the case vehicle's deploying driver side air bag caused fatal injuries to the case vehicle's driver.

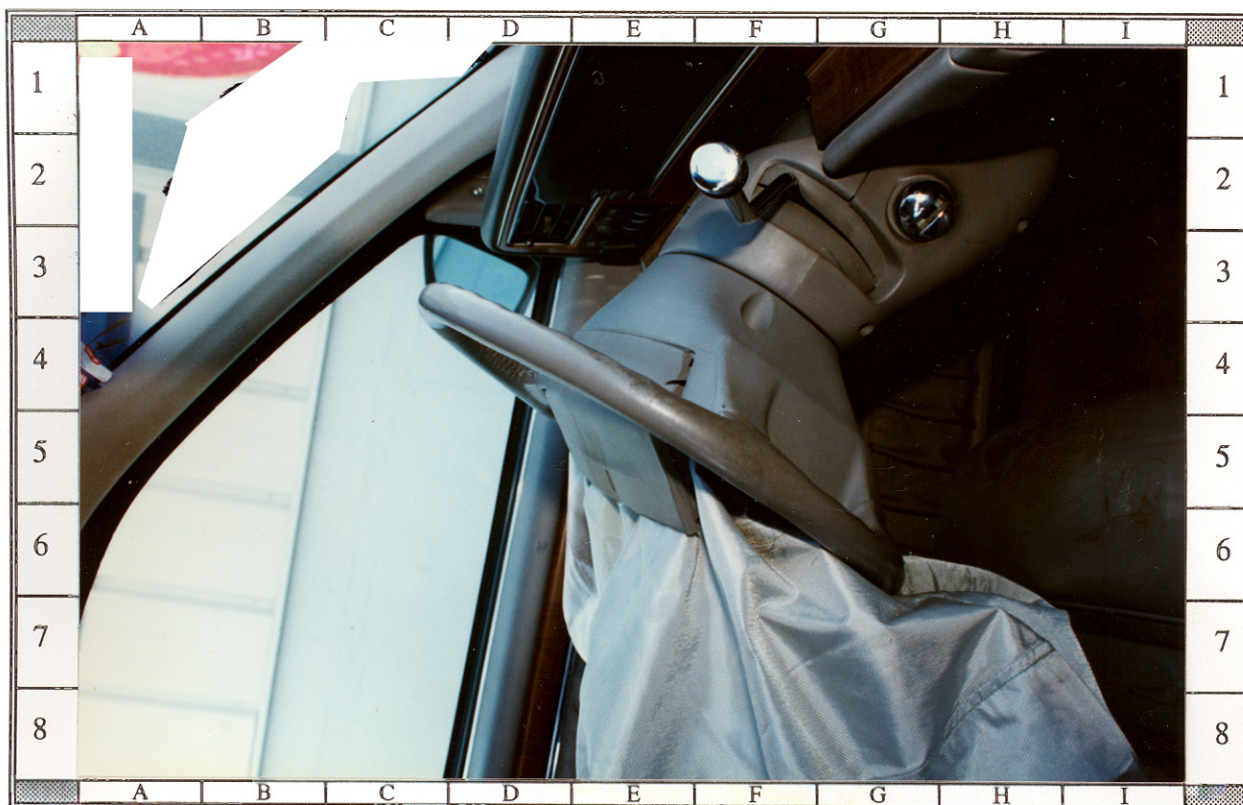
50 -- Close-up of 1990 Lincoln Continental's steering wheel rim; NOTE: no evidence of occupant loading to either column or rim

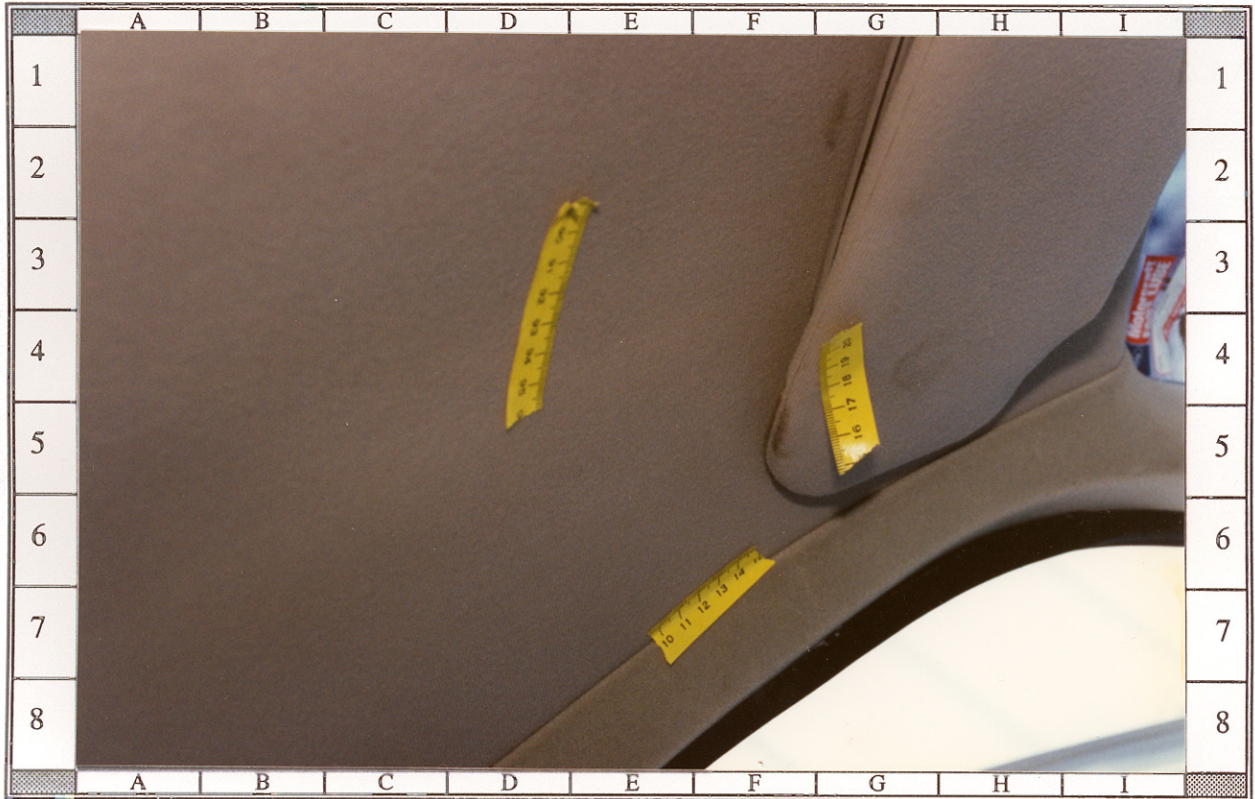
51 -- Close-up of driver contacts to 1990 Lincoln Continental's sunvisor, roof, and roof siderail; NOTE: roof dented slightly

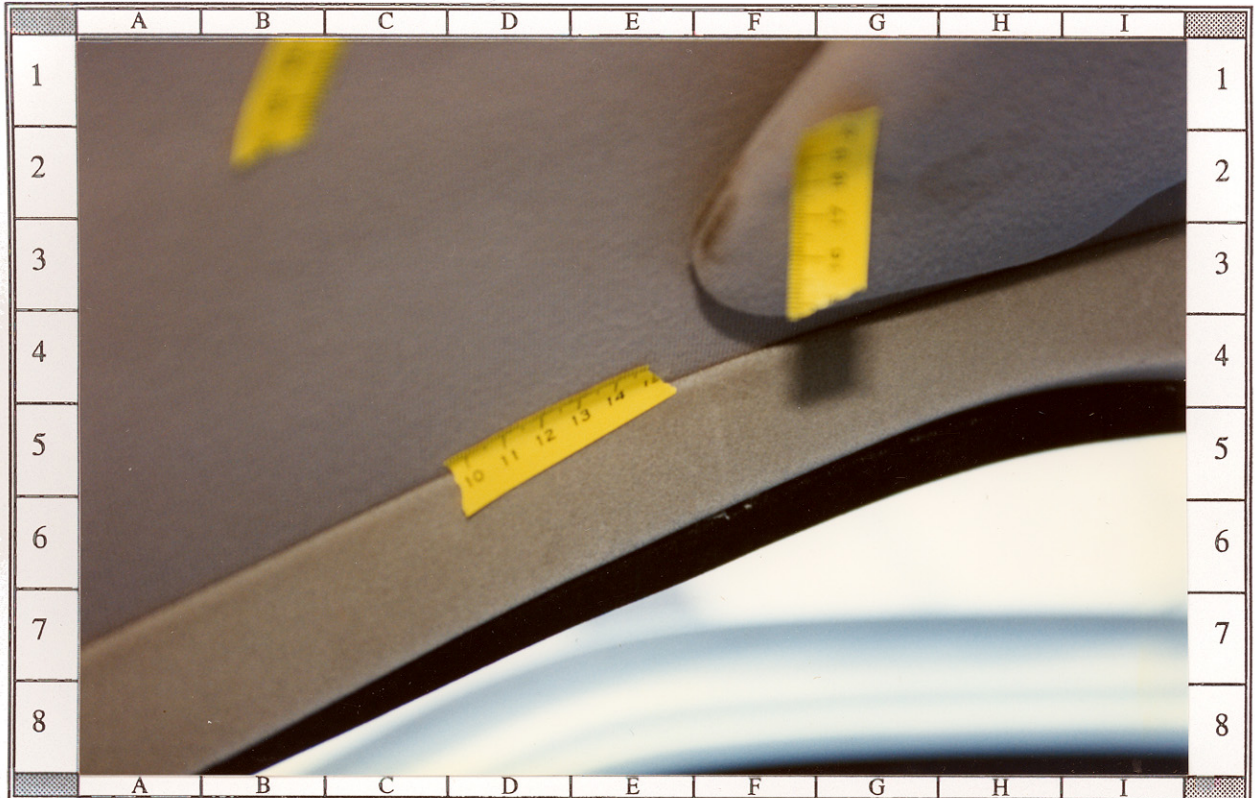
52 -- Closer-up of driver contacts to 1990 Lincoln Continental's sunvisor and roof siderail; NOTE: hair on siderail contact

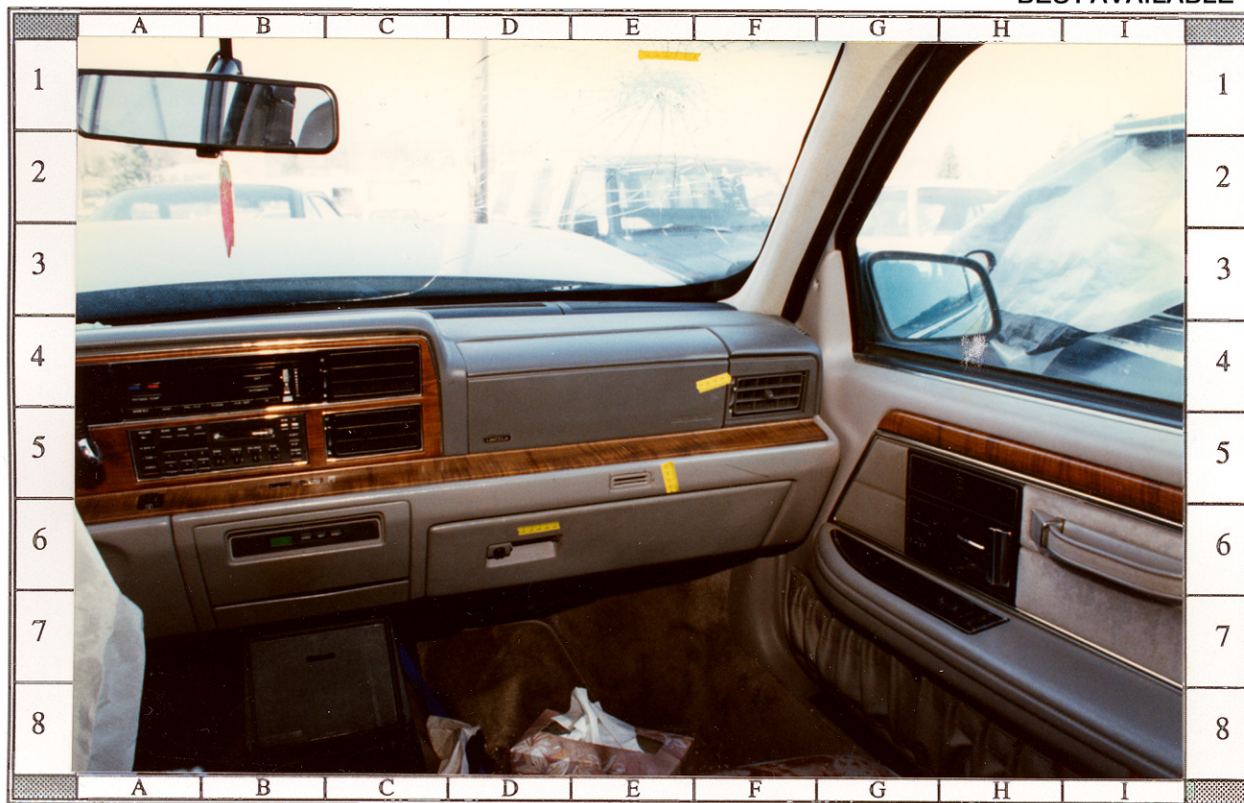
53 -- 1990 Lincoln Continental's CF control panel, glove box handle, and RF dash, A-pillar, and door showing RF passenger contacts

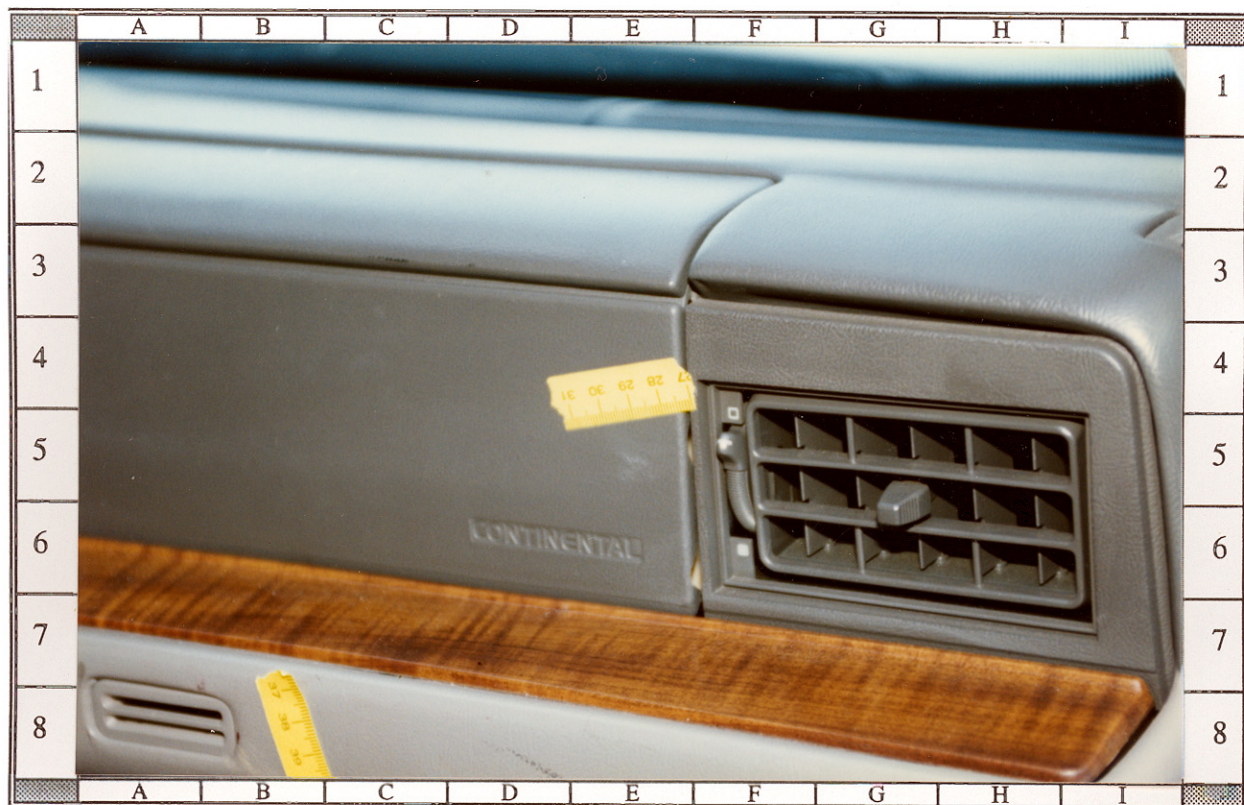
54 -- Close-up of 1990 Lincoln Continental's upper & mid RF dash showing contacts (skin transfers) by RF passenger

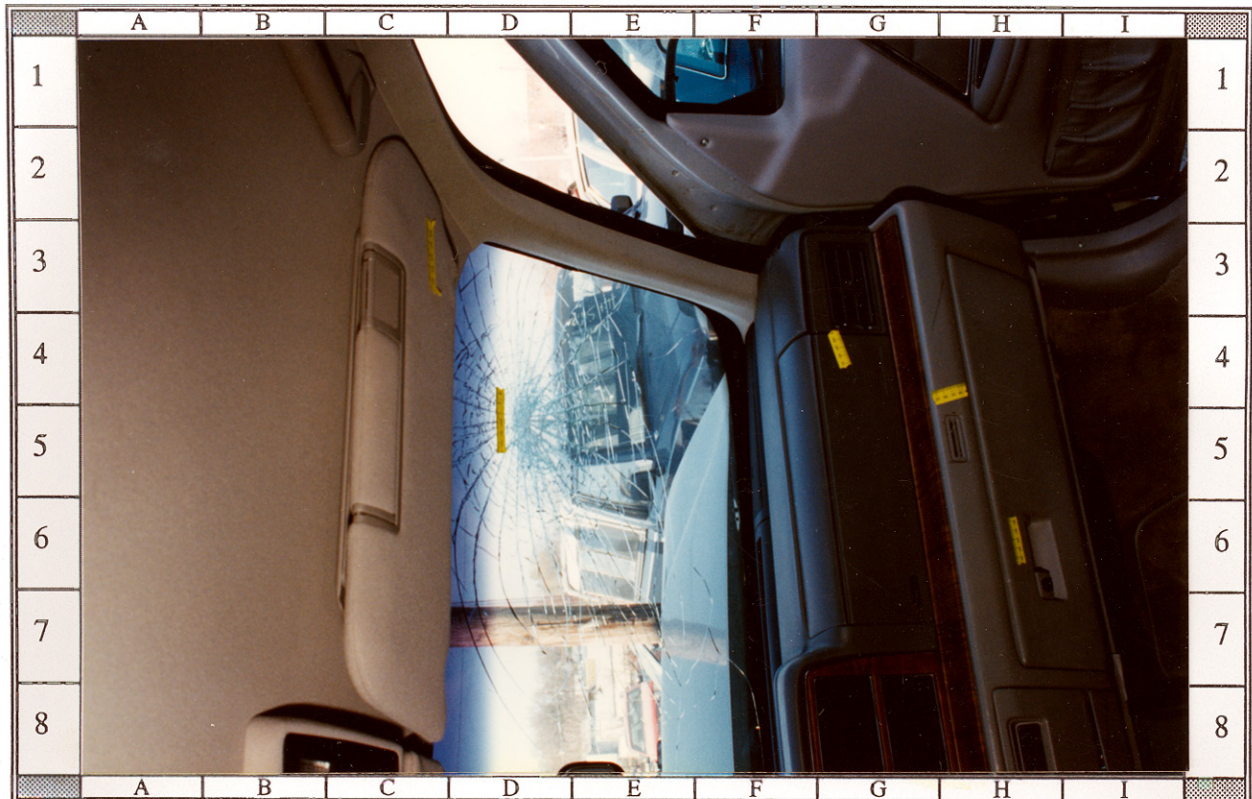
55 -- Close-up of 1990 Lincoln Continental's glove box handle broken by contact from right front passenger's left knee

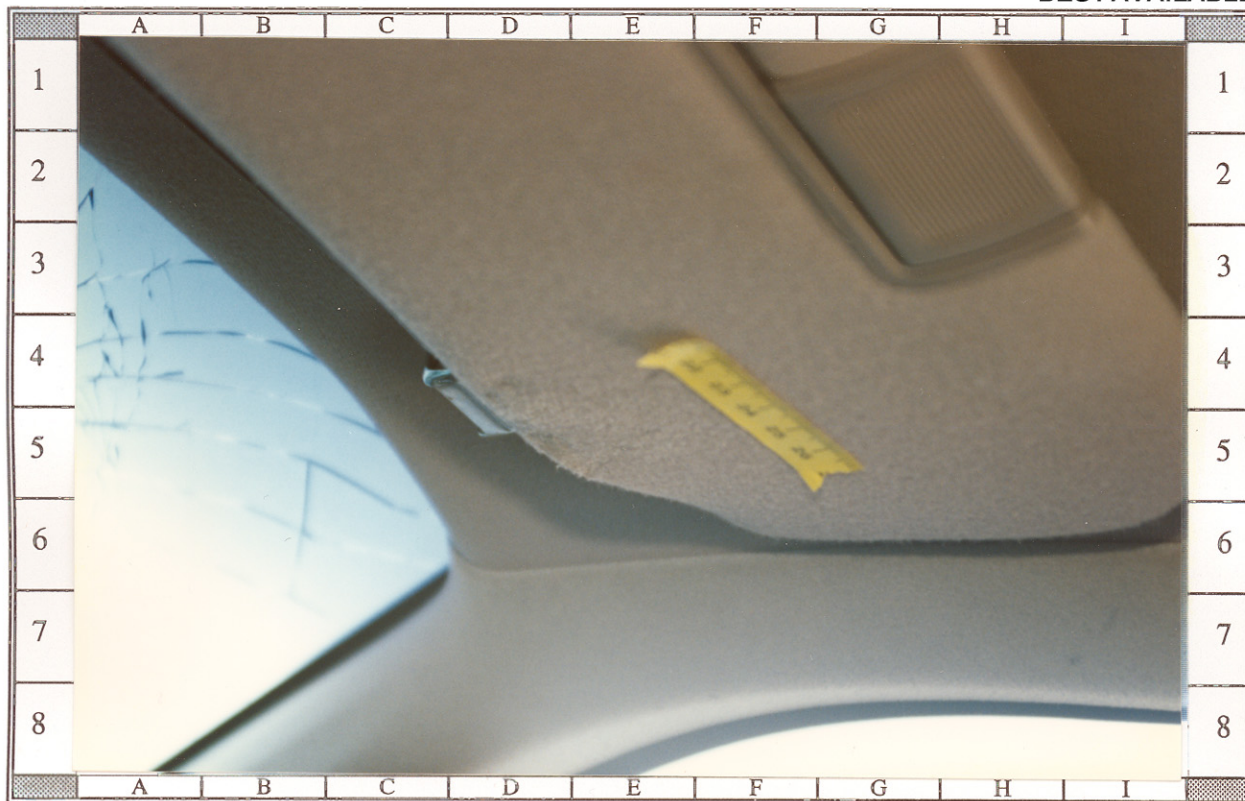
57 -- Close-up of '90 Lincoln Continental's right front sunvisor showing contact [skin transfer (cells D5--E5)] by RF passenger

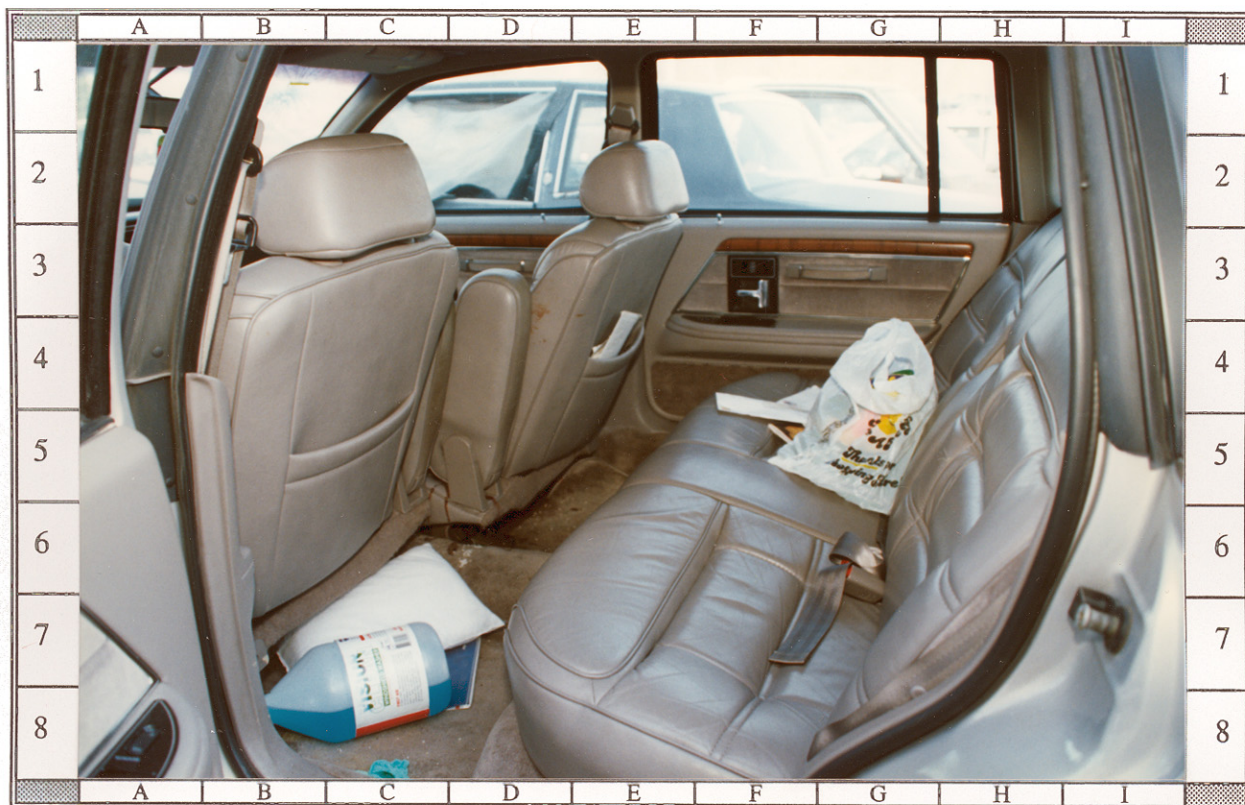
58 -- 1990 Lincoln Continental's rear seating area; NOTE: outboard 3-point manual belts and the far forward position of driver's seat

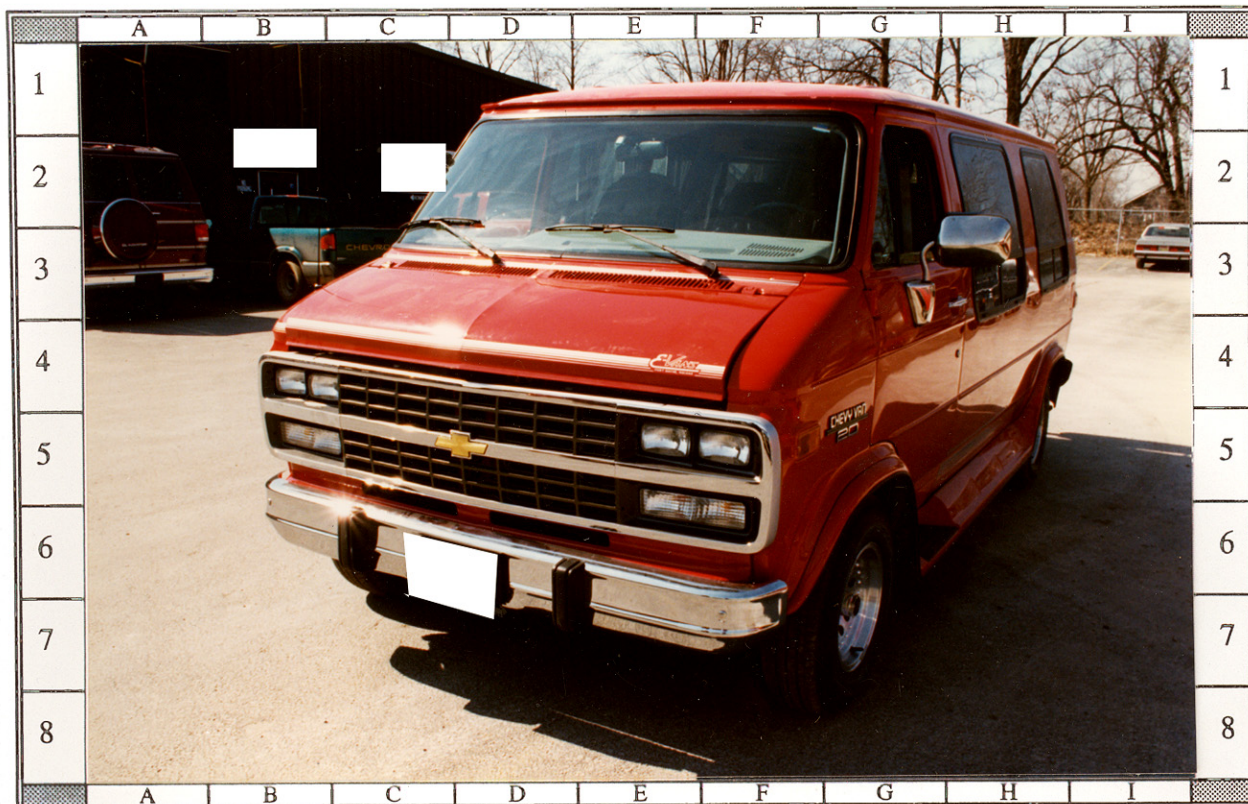
59 -- Front of 1993 Chevrolet C-20 conversion van; NOTE: van's front damage has been repaired--compare with photograph #23 above

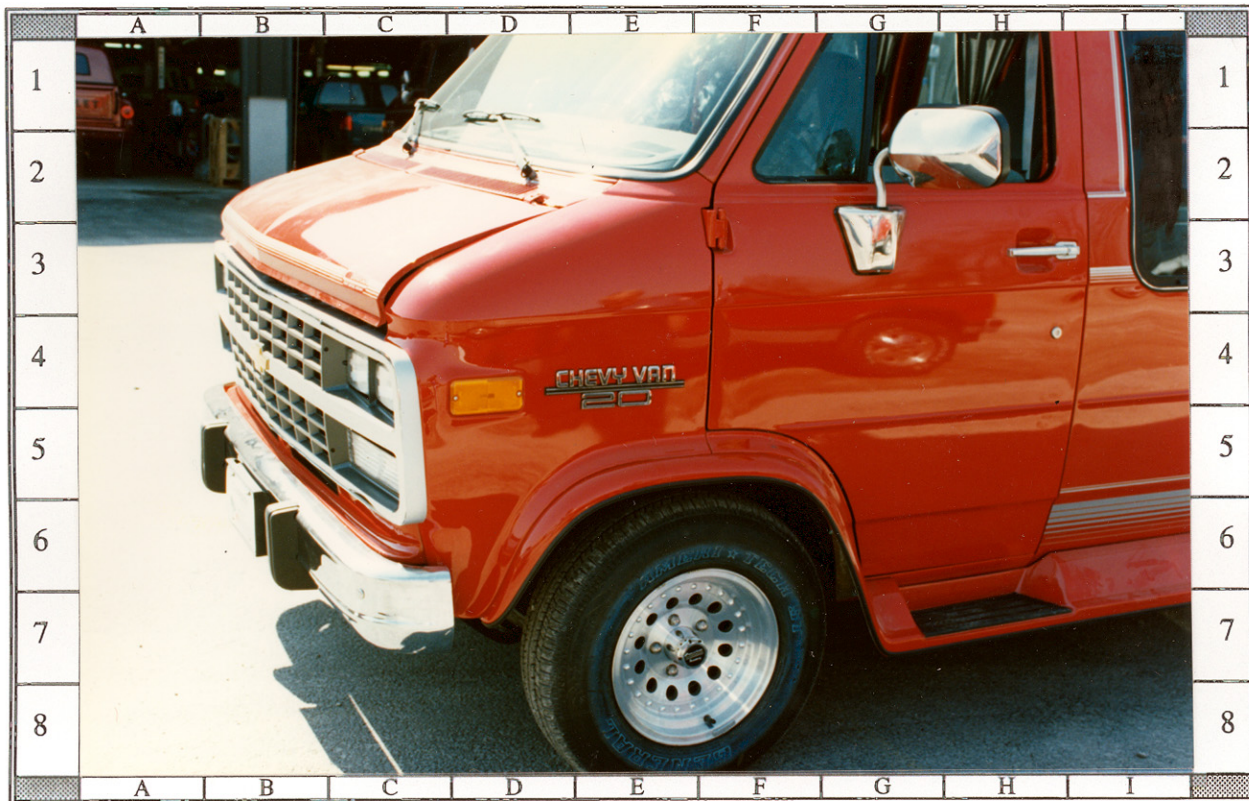
60 -- Repaired 1993 Chevrolet C-20 conversion van's front & LF from ~ 15 degrees left of front--compare with photos #21 & #23 above

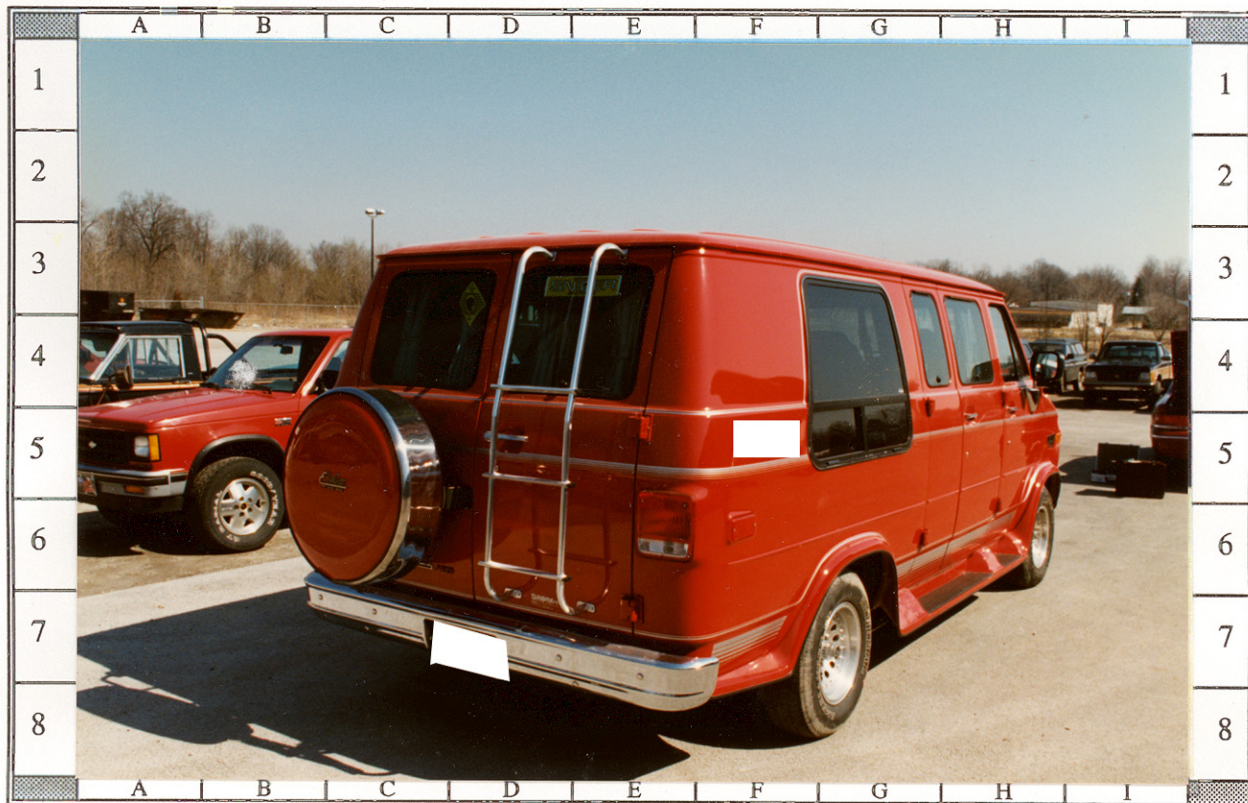
63 -- 1993 Chevrolet C-20 conversion van's undamaged right side & back from approximately 20 degrees right of back

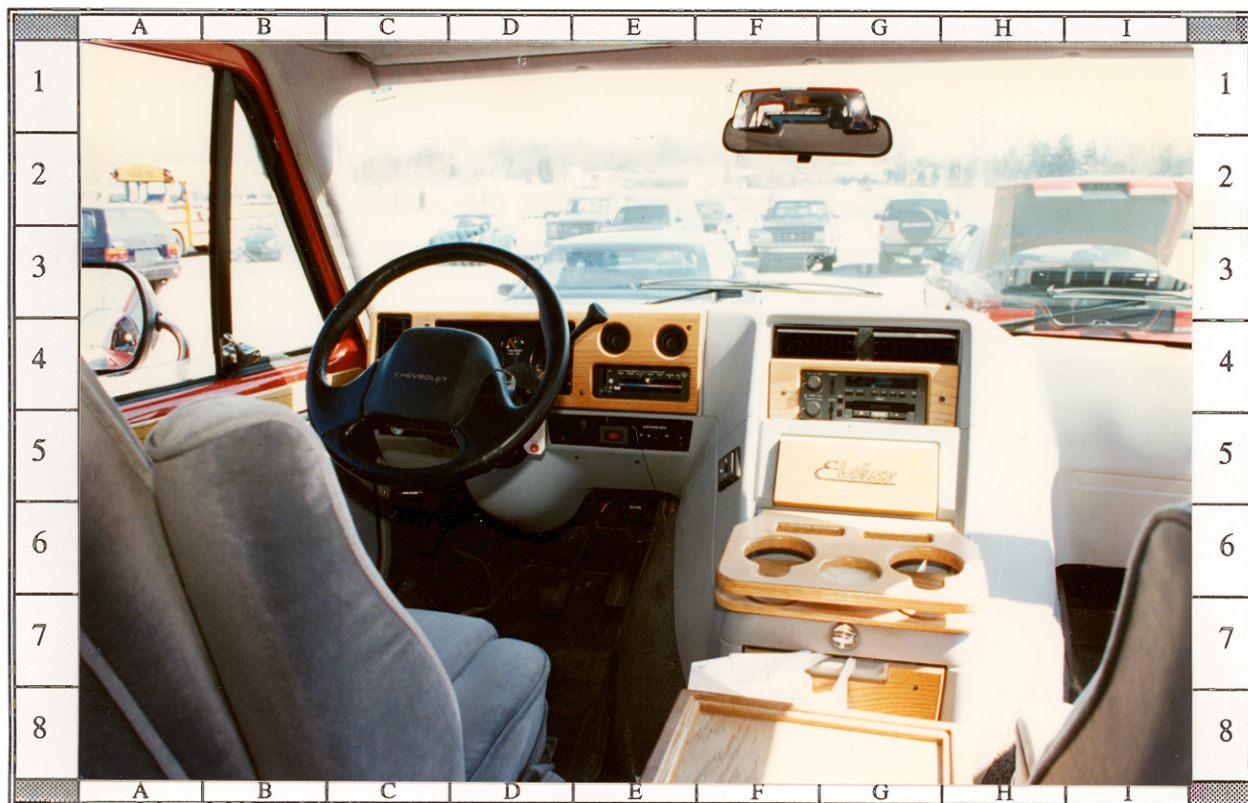
67 -- 1993 Chevrolet C-20 conversion van's driver seating area, center console, & greenhouse viewed from van's center middle area

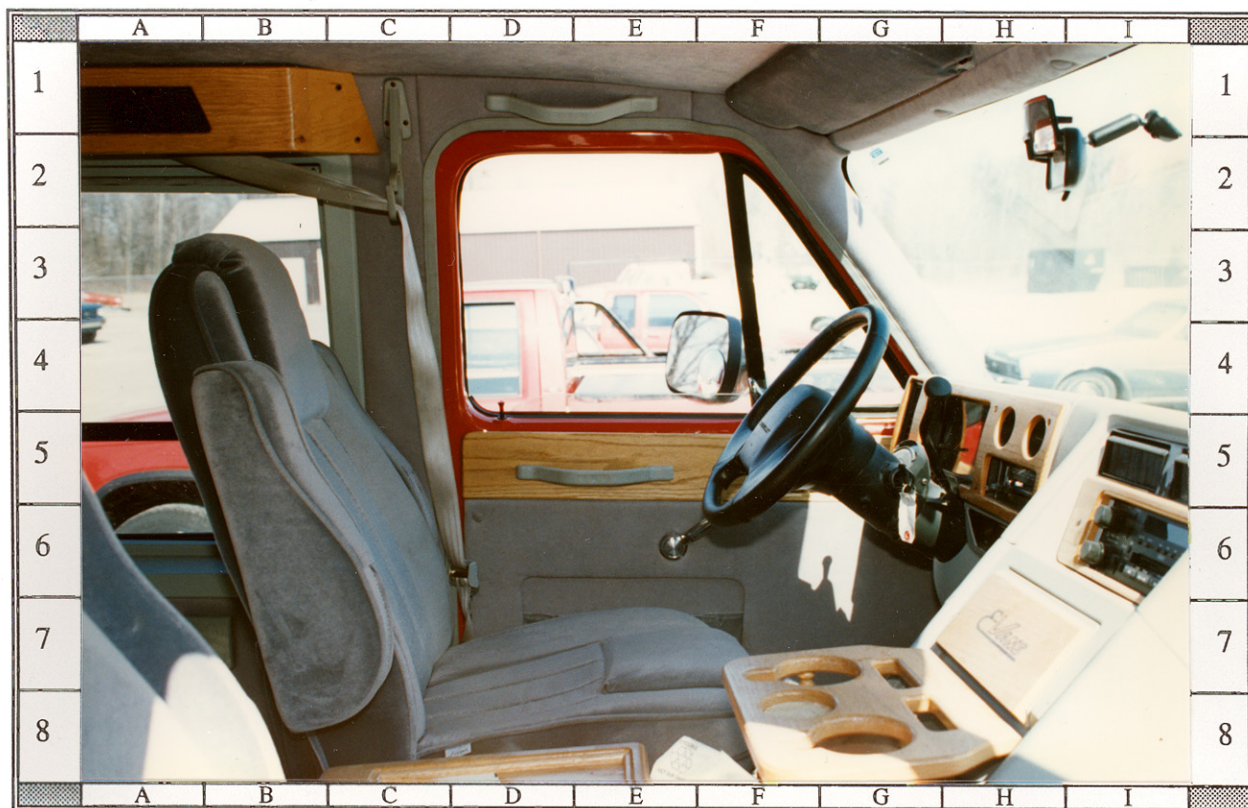
68 -- 1993 Chevrolet C-20 conversion van's driver seating area, center console, and greenhouse viewed from right front door area

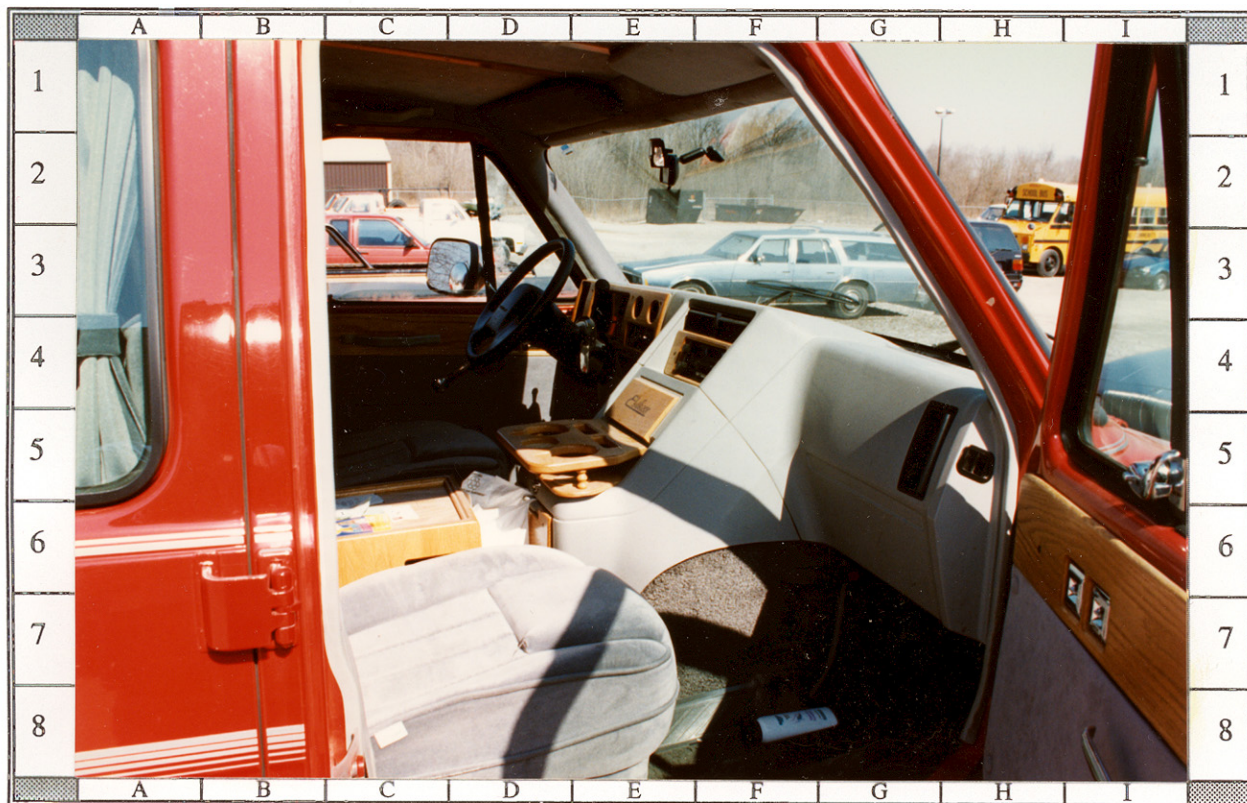
69 -- 1993 Chevrolet C-20 conversion van's right front seating area, center console, and greenhouse viewed from outside RF door

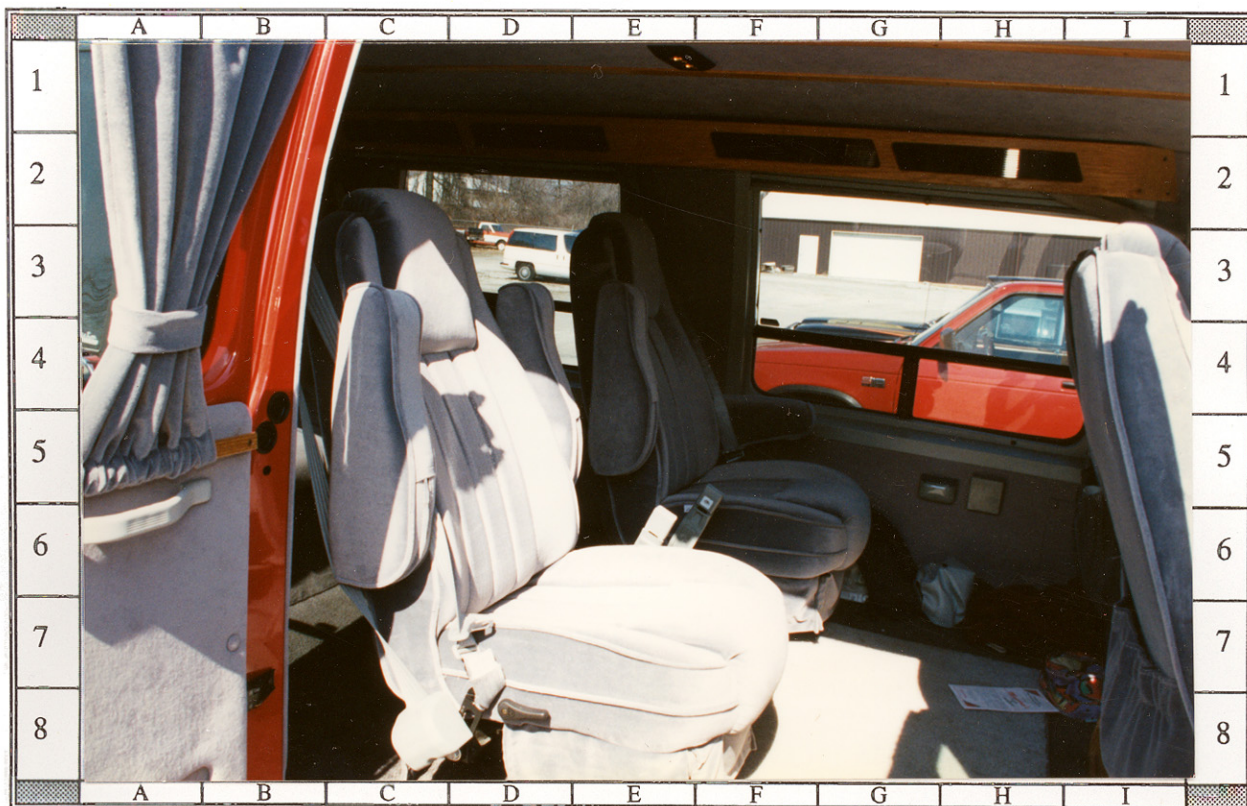
70 -- 1993 Chevrolet C-20 conversion van's middle row bucket seats viewed from outside the right side hinged door

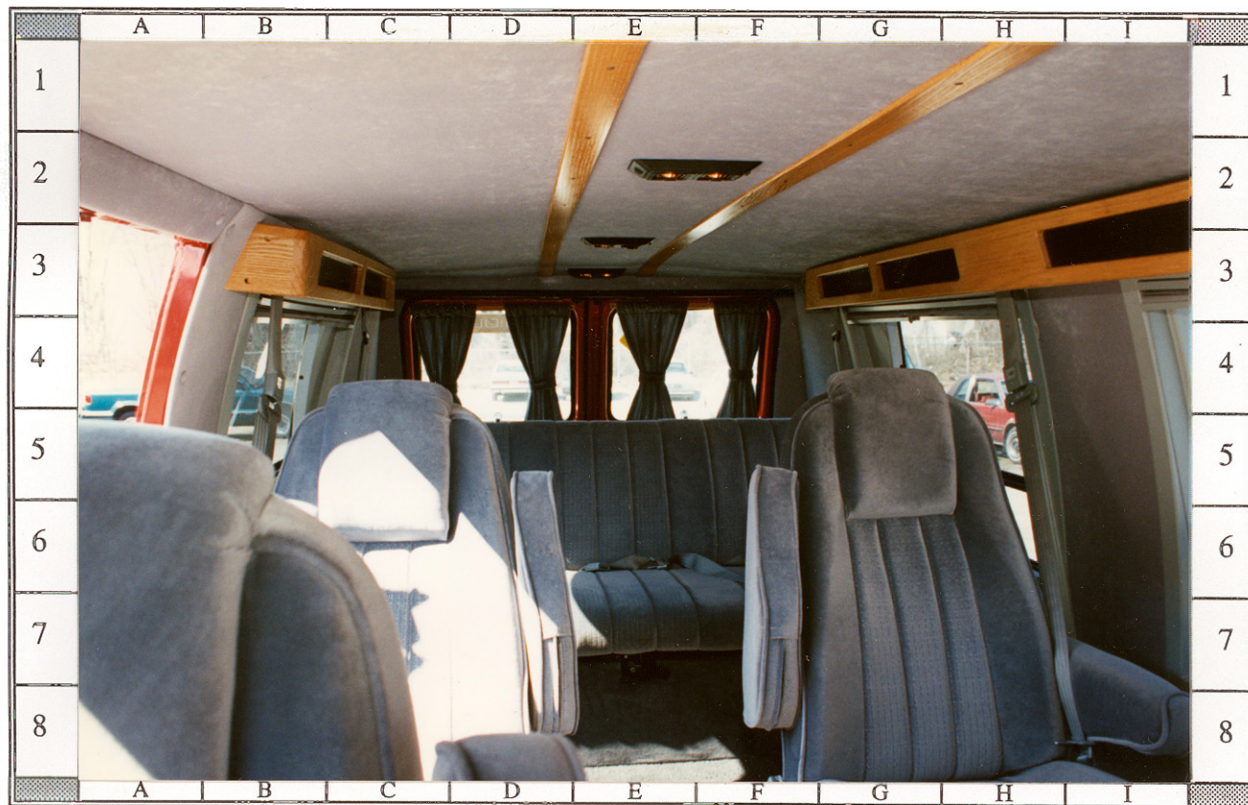
71 -- 1993 Chevrolet C-20 conversion van's middle bucket & rear fold-down bench seats; NOTE: outboard 3-point manual belts @ middle
